TEST REPORT

No.: SZIN2311002595PL02 EN

GNG Standard Gypsum Board

Test Item: Breaking load

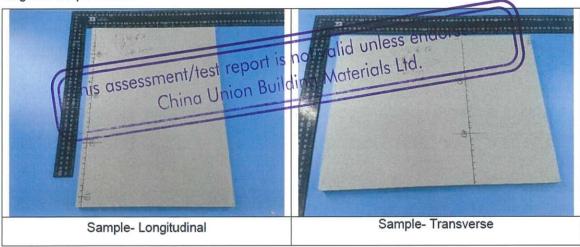
Original Sample Photo:

2440×1220×12

Sample Description: See photo
